Operating Experience Weekly Summary 97-45

October 31 through November 6, 1997

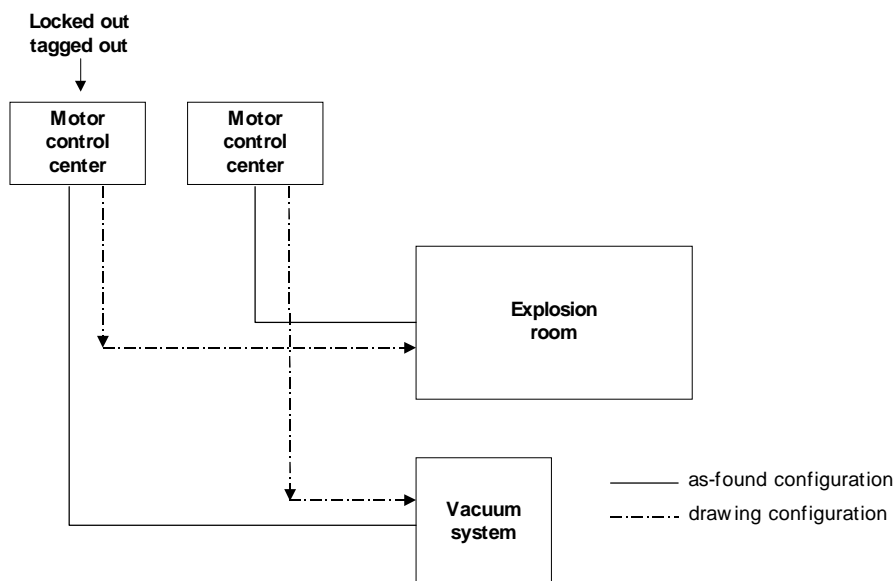
Figure 3-1. Simplified Configuration Schematic

On October 22, 1997, at the Hanford Site Plutonium Reclamation Facility, facility personnel discovered that electricians had locked out and tagged out the wrong motor control center in May 1997 because system drawings were incorrect. The electricians were performing work on a vacuum system that required actuation of a pump. However, the pump would not start; so they decided to troubleshoot the problem. They determined that the motor control center supplying power to the pump was locked out/tagged out instead of a motor control center that workers intended to lock and tag. Investigators determined that this event occurred because the motor control center was modified in 1995, and no one revised the drawings. Facility modifications without proper controls can result in hazards to individuals performing the work and in unauthorized configuration changes that lower safety margins. (ORPS Report RL--PHMC-PFP-1997-0042)

Investigators reported that electricians locked out and tagged out the motor control center cabinets after a chemical explosion in May 1997. The electricians needed to isolate power to the room to perform clean-up activities. They performed a zero energy check, but believed it was incorrect because of the extensive explosion damage. Therefore, they performed zero energy checks on each component each time they began work. While investigating the vacuum system problem, the electricians noticed that the labels on the motor control center cabinets did not match the loads identified on the drawings. They concluded that the wrong motor control center was locked out in May.

Investigators determined that the work package to isolate power to the room was based on incorrect drawings. They also determined that the drawings were correct before the 1995 modifications, but the tracking system failed to ensure drawings were updated. Figure 3-1 is a simplified schematic of the as-found configuration compared to the drawing configuration.

These events underscore the importance of correct drawings and a disciplined configuration management program. According to DOE facility representatives, a facility-wide upgrade of all drawings was performed in 1993. They believe the systems in place to track and monitor subsequent modifications and ensure incorporation of changes into documents failed to prevent this event. When facility managers become aware that their facility drawings may be incomplete or inaccurate, additional safety steps should be incorporated into work controls and maintenance activities. Facility managers should also ensure that configuration changes are incorporated into facility documents, equipment is properly labeled, and assessments are conducted to verify the configuration management program effectiveness.

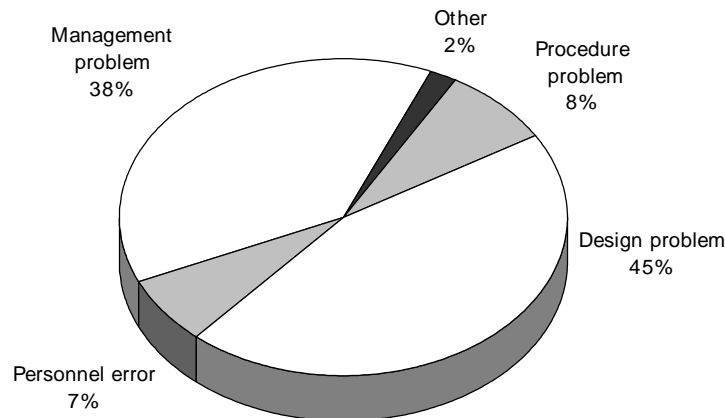
Figure 3-2. Root Causes for Drawing, Specification, or Data Errors¹

OEAF engineers searched the ORPS database for events with a direct cause of drawing, specification, or data error and found 216 events. Figure 3-2 shows the root causes for these events. A review of these occurrences shows that managers reported 45 percent of the root causes as design problems, with 84 percent attributed to drawing, specification, or data errors. The remaining design problems were attributed to inadequate work environment or inadequate or defective design. In addition, they reported 38 percent of the root causes as management problems. Of the management problems, 56 percent were attributed to inadequate administrative control or policy not adequately defined, disseminated, or enforced; and 21 percent were attributed to work organization/planning deficiency.

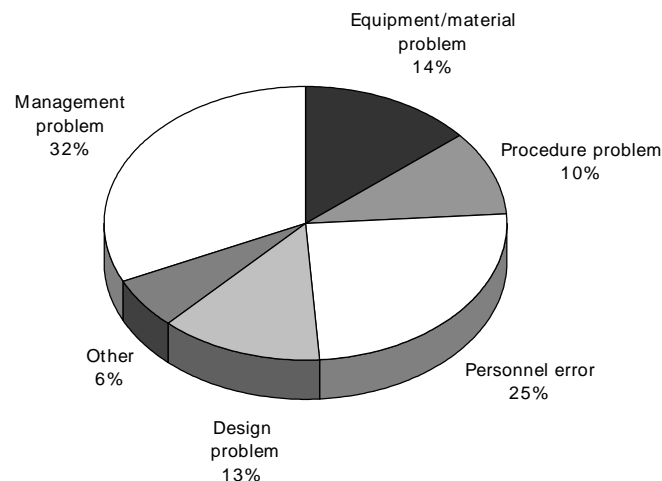
Figure 4-1. Root Causes for Hazardous Electrical Occurrences¹

OEAF engineers reviewed selected occurrences from the ORPS database from October 1, 1990 through September 30, 1997, for hazardous electrical occurrences and found 742 reports. More than half of the occurrences had a root cause of either management problems or personnel error. About 27 percent of the management problems resulted from inadequate administrative control; 26 percent resulted from inadequate policy dissemination and enforcement; and about 22 percent resulted from work-planning deficiencies. About 42 percent of the personnel errors involved failure to follow procedures, and 41 percent were inattention to detail. Taken together, the data indicates that nearly 70 percent of all occurrences could be eliminated by a well-trained, well-managed, attentive work force using good procedures. Figure 4-1 shows the distribution for hazardous electrical occurrences.

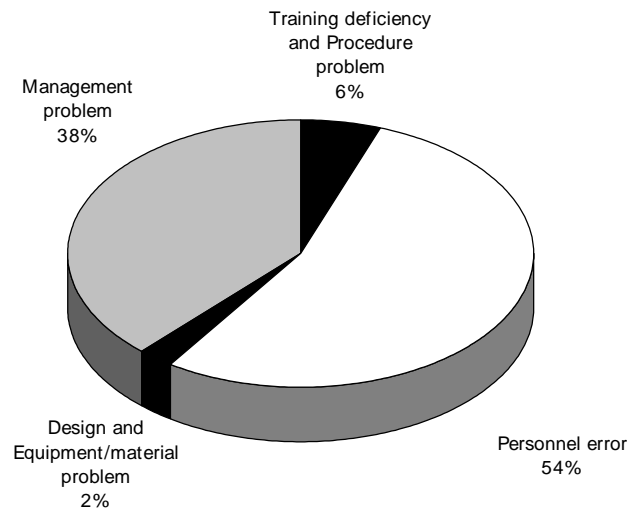
Figure 5-1. Distribution of Root Causes for Radiological Work Permit Violations¹

OEAF engineers searched ORPS database from 1995 to present for violations of radiological work permits across the DOE complex and found 122 occurrences. Figure 5-1 shows that facility managers reported personnel error as the root cause for 54 percent of the occurrences. They also reported that management problems accounted for 38 percent of the violations. Further review shows that 50 percent of the personnel errors were reported as procedure not used or used incorrectly and 43 percent as inattention to detail. Inadequate administrative control accounted for 40 percent of the management problems.

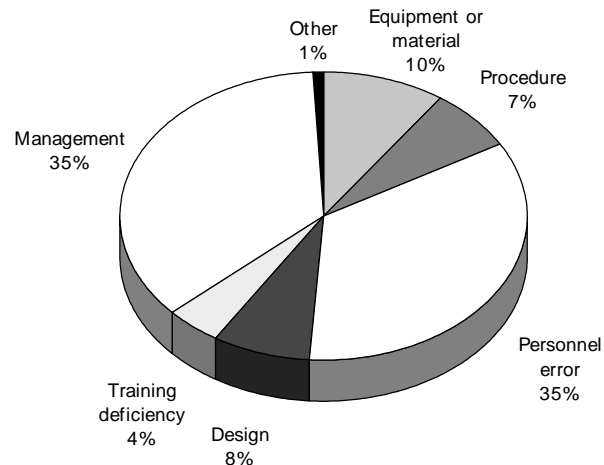
Figure 6-1. Root Causes for Lockout/Tagout Events DOE-Wide¹

OEAF engineers searched the ORPS database for reports involving lockout/tagout events and found 1,835 occurrences DOE-wide. Figure 6-1 shows the distribution of root causes reported by facility managers for these events. Personnel error represented 35 percent of the root causes; management problems also represented 35 percent. Further review of the personnel errors shows that 43 percent were caused by inattention to detail and 43 percent by procedure not used or used incorrectly. A review of the management problems shows that 34 percent were caused by inadequate administrative control and 28 percent by policy not adequately defined, disseminated, or enforced.
